1. Photographic Summary of Apollo 11 Mission

James H. Sasser

A brief description of the Apollo 11 mission, illustrated with photographs taken by the astronauts during the mission, is presented. All photography in this chapter was taken on 70-mm film with Hasselblad cameras except figure 1. The cameras have a motor-driven mechanism powered by two nickel-cadmium batteries to advance the film and cock the shutter after each picture is taken. The photographs taken from the command module (CM) were made with 80- or 250-mm lenses. The lunar surface photography was taken with 80- and 60-mm lenses. The small crosses seen in the lunar surface photography are reseau marks that are used for calibration purposes during postflight data reduction. A 16-mm sequence camera for data acquisition was used to document many phases of the mission.

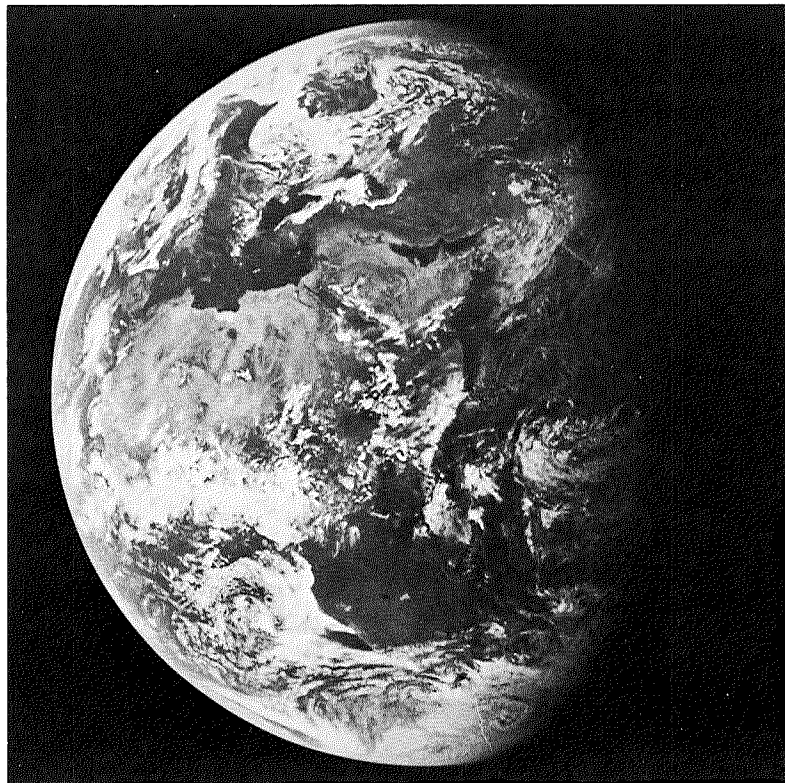
FIGURE 1-6. — This photograph (NASA AS11-36-5355) of the Earth, taken from a distance of more than 100 000 n.mi., was made approximately 25 hr after launch. The Eastern Hemisphere was remarkably cloud-free.

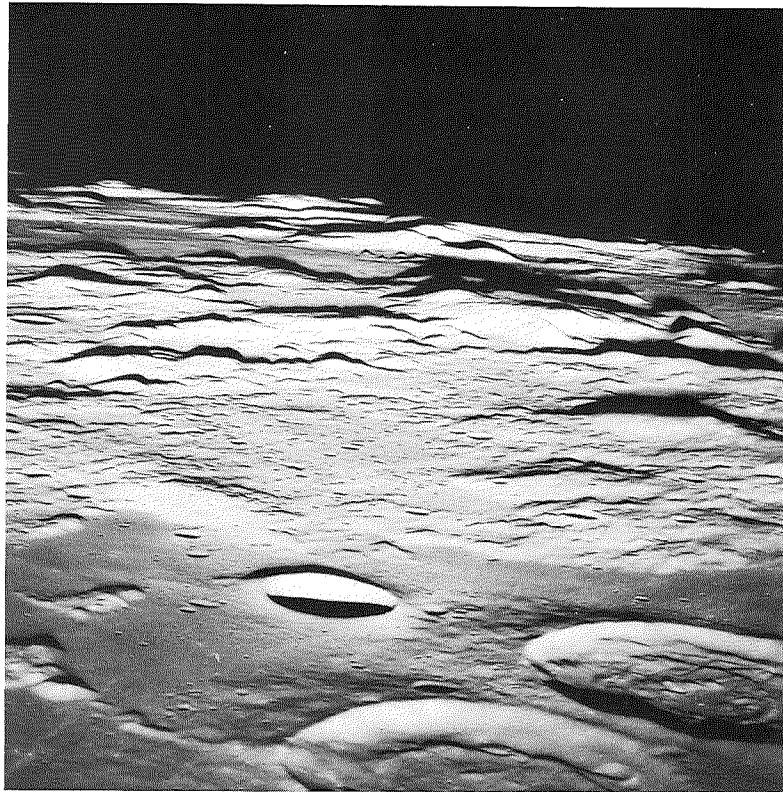
FIGURE 1-17. — The lunar highlands west of the Sea of Tranquility stand out in stark relief when illuminated by the morning Sun. The twin craters Sabine and Ritter are in the right foreground, and the crater Schmidt is in the central foreground. (NASA AS11-41-6123)
